Exhibit C1

Re: 82-88 Fulton Street
New York, NY
Block: 77 Lot: 24

As per your request, an exterior survey of 82 Fulton Street was conducted on July 28, 2020 at approximately 2:00 pm in the afternoon. The survey consisted of walking around the public area of the two story, retail space, which was open to the public only. No survey of any interior retail space was conducted as per your instruction.

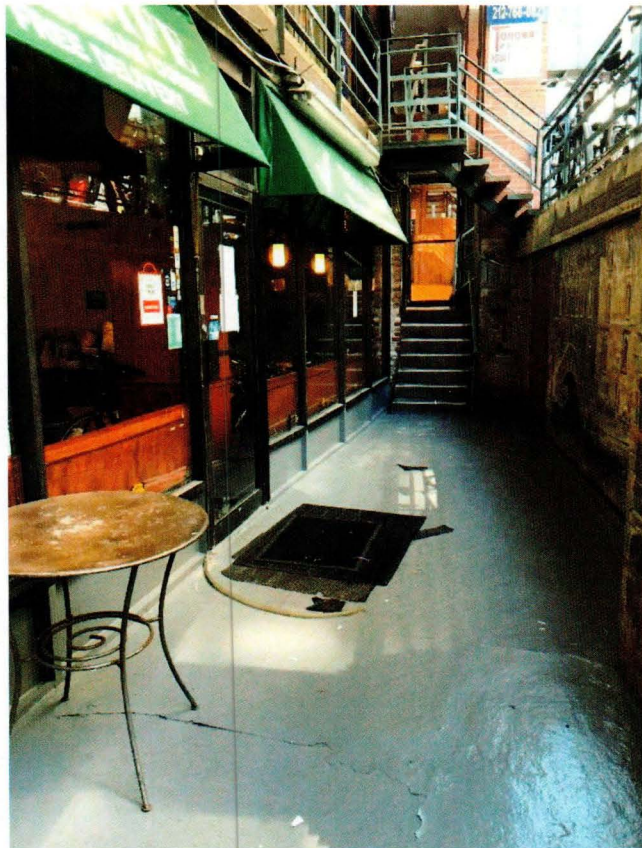
Figure 1-looking at exterior stair

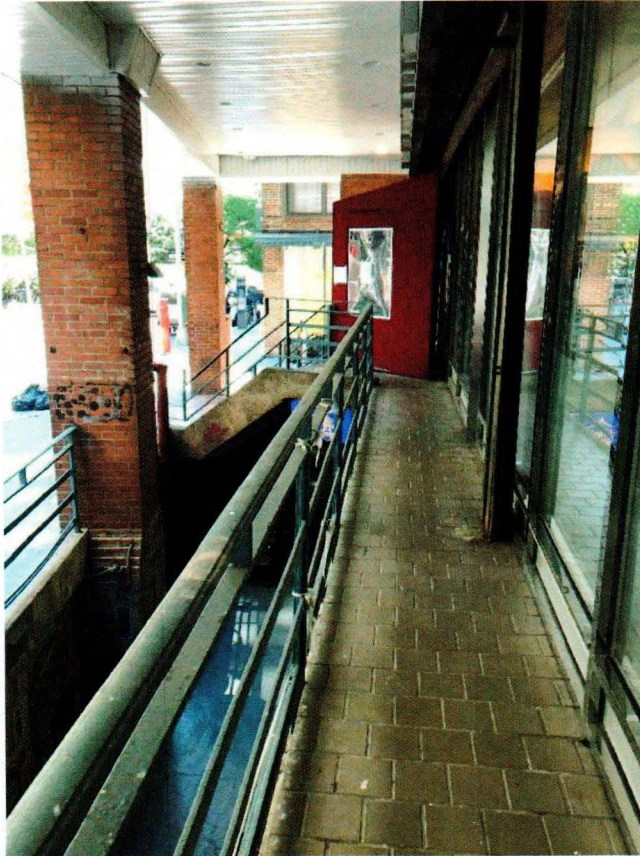
Figure 2-looking at walkway in front of retail space

In looking at the layout of the existing retail space, a ramp solution would not be feasible, since there would not be enough room and clearance to make a handicap ramp work, especially with having to work with five different levels. The best case solution would be to create two different sets of handicap accessible lifts. One for the left side of the building and one for the right side of the building along Fulton Street. The lift could be installed within the building's envelope, taking over some retail space. The amount of space required would be dependent on how the lift is design and oriented. The only drawback with the lift solution is for the Spa. Without conducting an interior survey, there is no way to tell if the lift will be able to provide access to the rest of the Spa space. Although designated as a landmark by New York City, it is not listed as such on the National Registry and this place of public accommodation must still be in compliance with the Americans With Disabilities Act. As such, approval for plans for ADA compliance is only required from New York City. As a practical matter, the burden is on the facility owner, tenant or manager to prove the threat to the historic facility. It is a narrowly interpreted exception to the global requirements of the ADA and would necessitate drawings
